TEST REPORT

NST/GW131423-2-

Cable Gland

AG-25

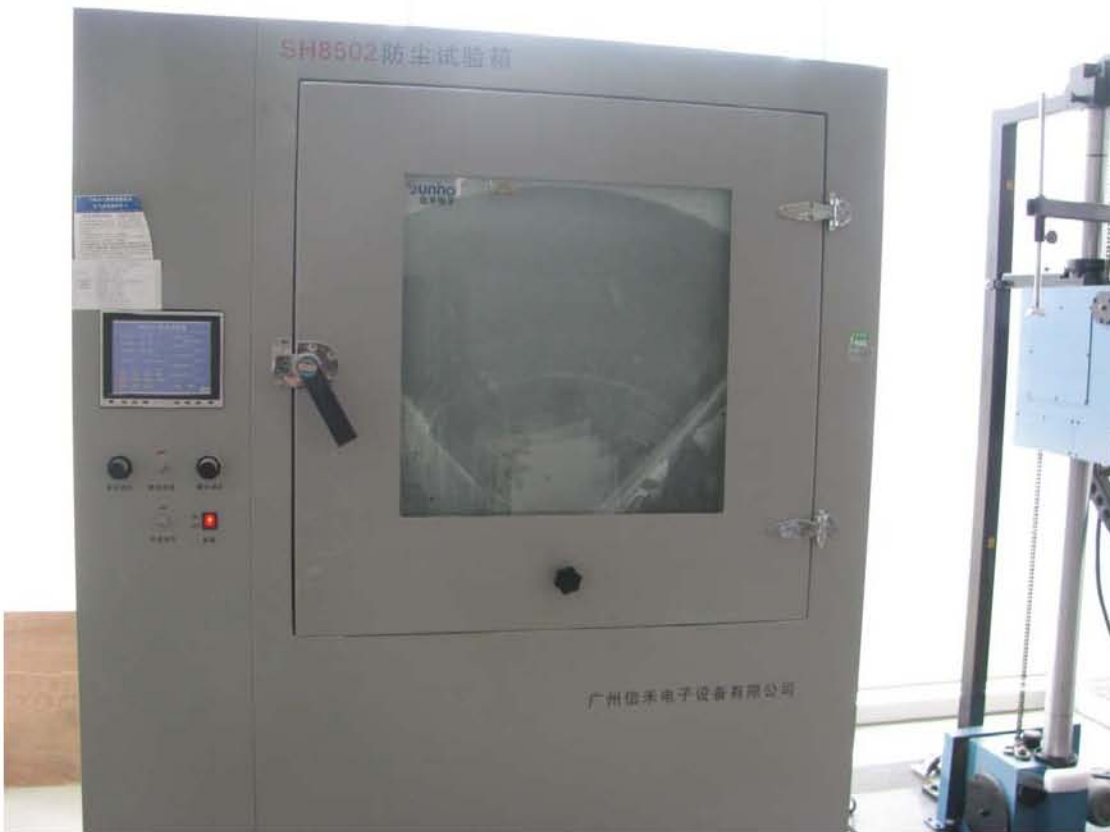
Photograph:

Standard:	IEC60529:2001
IP code:	IP68
Operating conditions:	IP6X: The object is freely suspended in the dust chamber, lasted 8 hours with the depression not exceed 2KPa, the pressure inside the enclosure is maintained below the surrounding atmospheric pressure by a vaccum pump.
Phenomenon(after the test):	IP6X: No deposit of dust is observable inside the sample at the end of the test. So the protection is satisfactory.

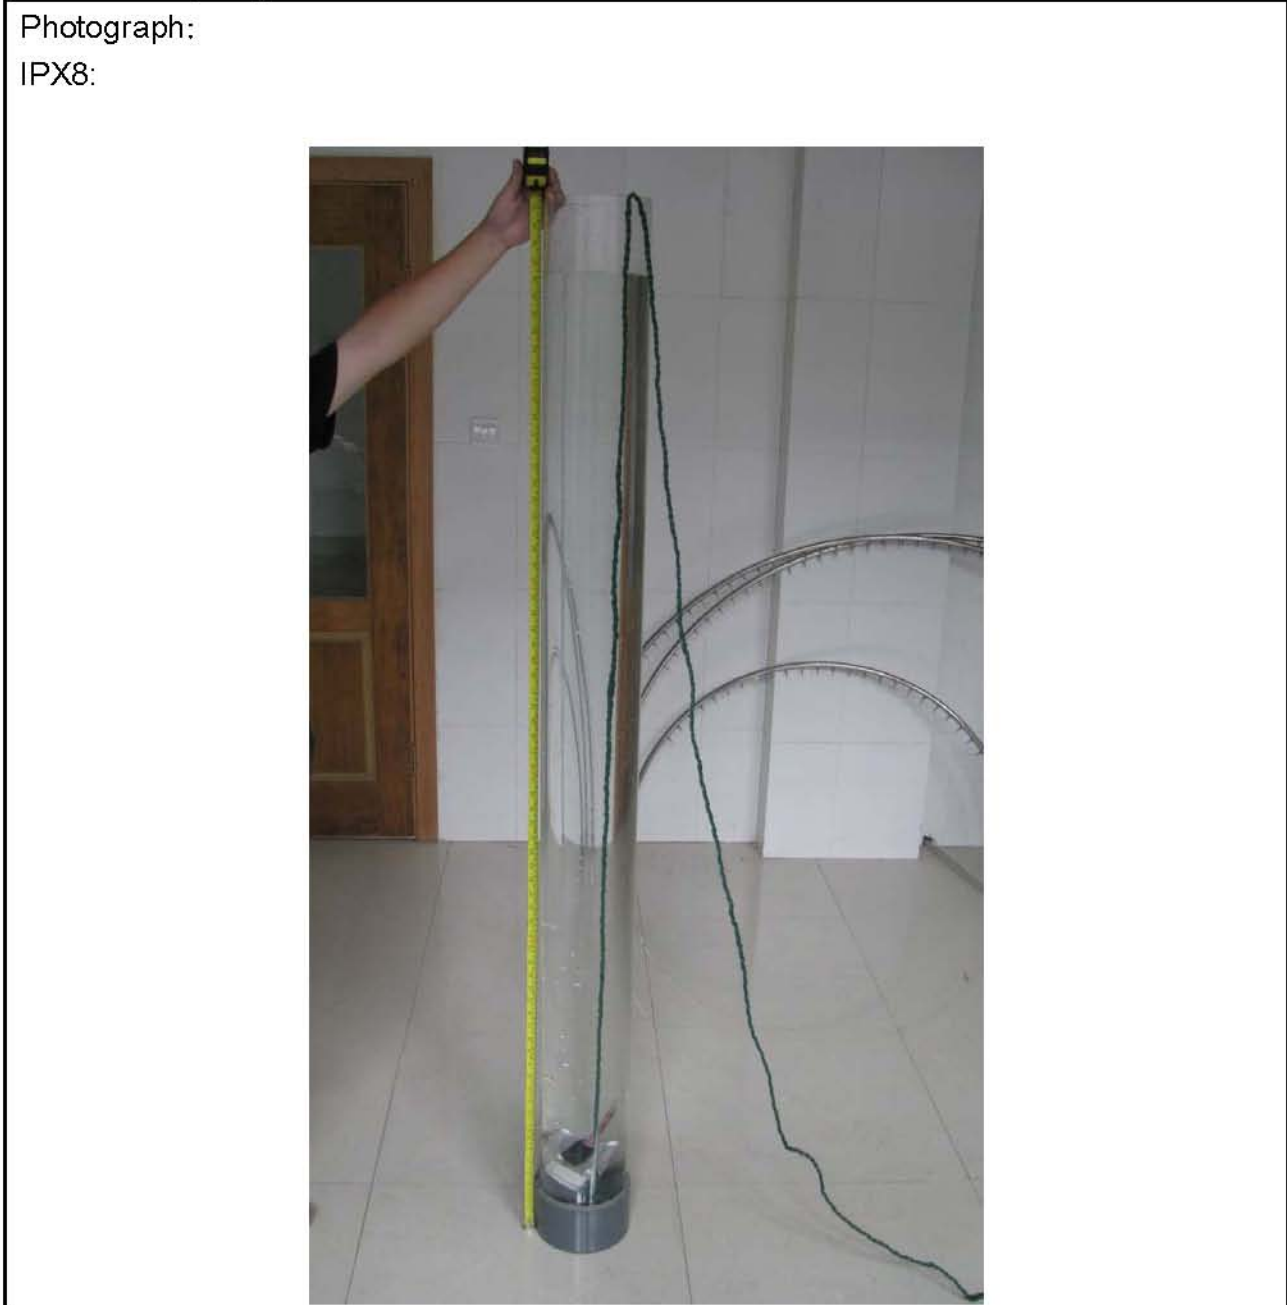
Testing description:	
Standard:	IEC60529:2001
IP code	IP68
Operating conditions:	IPX8: The lowest point of enclosures is located 1.5m below the surface of the water, the duration of the test is 35min; the water temperature does not differ from that of the equipment by more than 5K.
Phenomenon(after the test):	IPX8: No water entered.
